PASSIVELY MODE-LOCKED Nd-YAG OSCIL-LATOR STABILITY STUDY

Naval Research Laboratory

November 1973

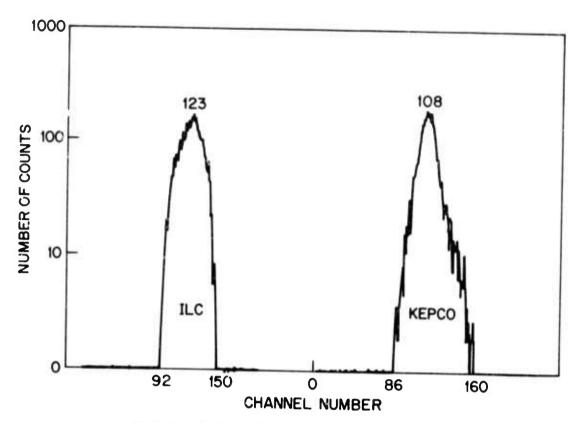
The real progress come when the air conditioning went hay wire during a simmer supply test with the Kepco and ILC supplies over a two and one half hour period. As can be seen in Figure 3, the distributions so obtained were not normal distributions. Since external temperature was causing such a big effect, two 80 minute distributions were recorded and superimposed in Figure 4. Here appear two narrow distributions whose sum over a longer recording period would have been a much wider distribution. At this point the study became an attempt to locate the most temperature sensitive parts of the oscillator.

Fig. 3 - 2½ hour test, air conditioning failed

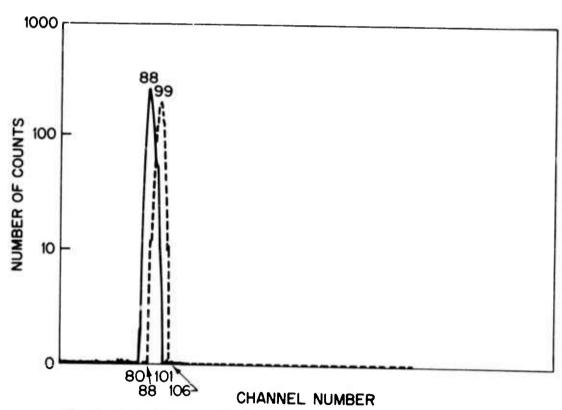
Fig. 4 - Two successive 80 minute tests, air conditioning failed
